Pilot Testing of Mercury Oxidation Catalysts for Upstream of Wet FGD Systems

Quarterly Technical Progress Report

April 1, 2003 – June 30, 2003

**URS Corporation
9400 Amberglen Boulevard
Austin, Texas 78729**

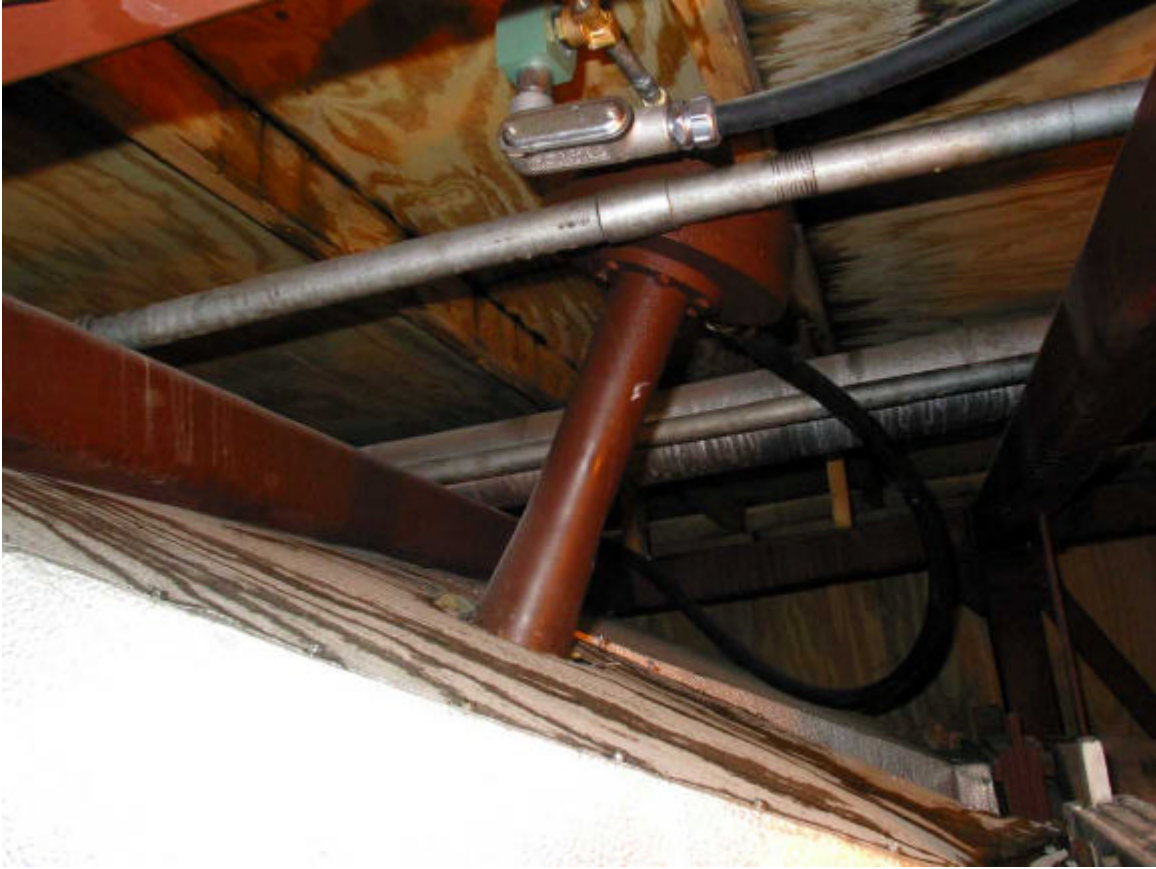
Figure 3. Typical Sonic Horn Installation on the Pilot Unit at CCS.

The horns were installed on the other three compartments (the initial horn remained on the Pd #1 compartment), and the fourth catalyst (C #6) was installed. Figure 3 shows a typical sonic horn installation on a catalyst chamber inlet transition duct.
